# Inspection Bulletin

## North American Standard Inspection Program

### 2022-04 – Passenger Carrier Vehicle Emergency Exit Inspection

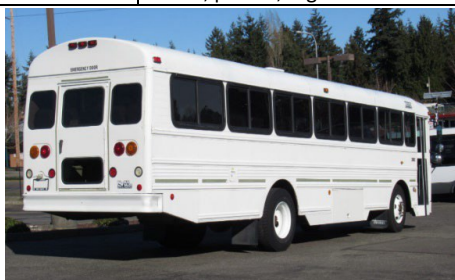
A commercial bus certifying under the PCVI Method Two Option A.

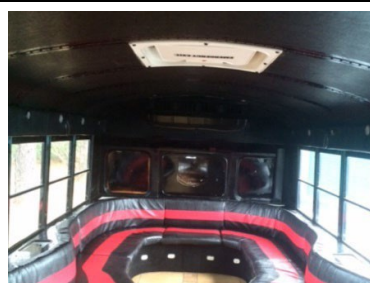
This converted school bus no longer meets Method Two Option A due to the removal of the rear exit door. A roof hatch has been added to comply with Method One.

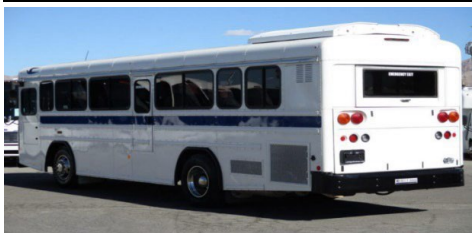
A commercial bus certifying under the PCVI Method Two Option B.

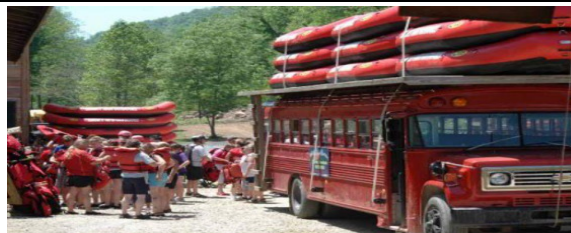
Providing transportation to adults will reduce the manufacturer's pupil seating capacity from three to two per seating surface. This bus does not require a roof hatch if the seating capacity is under 63 for Option A or under 75 for Option B.

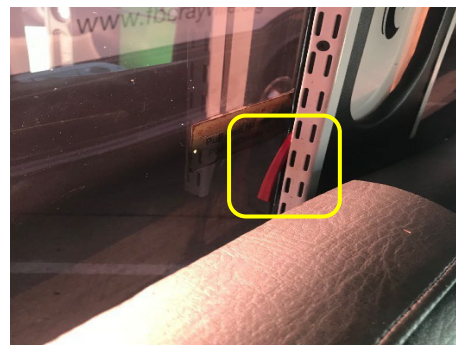
Custom panel and seatback blocking the release mechanism, making the exit inoperative.

If the modifier fails to redesign the emergency exit to relocate the release mechanism(s) to the specified region(s) and the exit cannot be opened during the inspection process without the use of a tool, the mechanism is considered blocked, and an out-of-service condition is present for "required/marked emergency exit obstructed." If the exit is operative (without the use of a tool) but the release handle is not located within the required area, a violation is present. (393.62(a)-(571.217 S5.3.1))

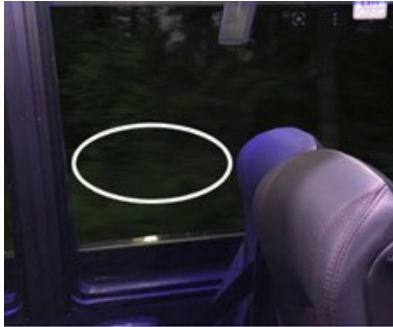
TV monitor and high back seat dividing the emergency exit space yet allowing passage through the exit.

**NOTE:** A violation is **NOT** present if the required ellipsoid dimension remains passable through the exit.

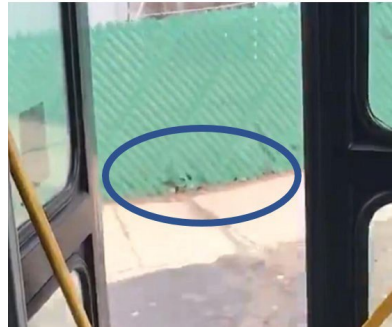
Only one side of double door opens when release is activated. The one door opening allows adequate passage of the ellipsoid through the exit.

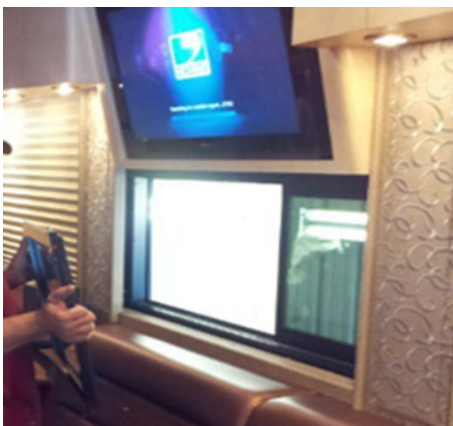
Exit designed to press down pins and lift window out of track. TV and panels installed to allow access and removal as designed.

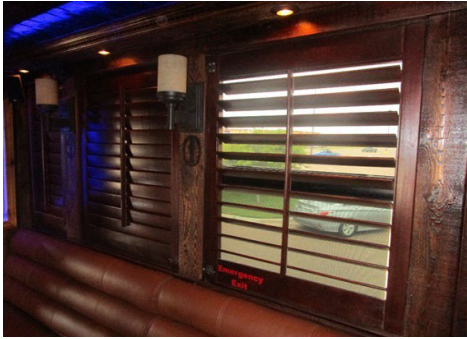
Exit obstructed by wooden plantation shutters.

- 4. Unobstructed Access.** If an interior customization or other obstruction hinders access to the marked and/or required emergency exit, an out-of-service condition is present for “required/marked emergency exit obstructed” (393.62(a)-(571.217 S5.2.2.1)). For buses less than 10,001 lbs. (4,536 kg), 393.62(a)-(571.217 S5.2.2.3).

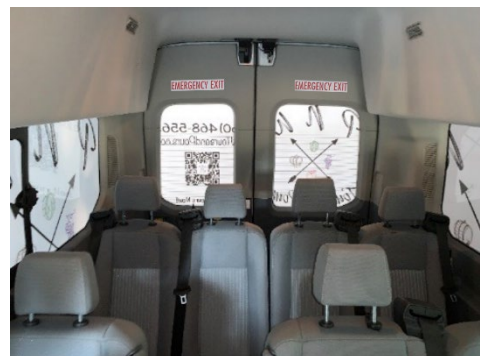
**NOTE: Rear Emergency Exit Door** - In the case of a rear emergency exit door, a seatback or other interior component forward of the exit space does not necessarily render the exit unusable. When the rear door is opened, if the space behind the seatback or interior component is large enough to accommodate a rectangular shape 45 inches (1145 mm) high, 24 inches (610 mm) wide and 12 inches (305 mm) deep, an obstruction to the exit or a reduction of the area credited to the rear emergency door is not present. In addition, the space between the top of the seat (or other surface) and the roof must meet the unobstructed passage of a 19.7 x 13-inch (50 cm x 33 cm) ellipsoid. This allowance is considered, due to the fact people will be moving along an interior surface other than the floor if the vehicle is on its side or roof following an accident.

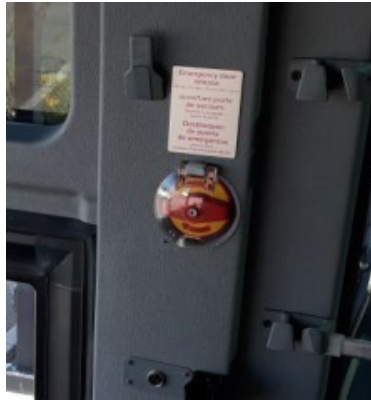
Door release valve inside a motorcoach at the entrance door.

**Front Entrance (Service) Doors:** Many passenger carrier vehicle front entrance doors (service) doors are locked by an internal system rather than manual door handles. In the event of a malfunction in the electrical system, or an inoperative door circuit, a valve is provided inside and/or outside to exit the bus. These valves may be marked "Emergency Door Release or Emergency Exit" with instructions indicating a direction to turn the knob to release the door. Even though the valve is provided as an emergency release, the entrance door may not necessarily be a required exit and therefore not marked as an emergency door or emergency exit.

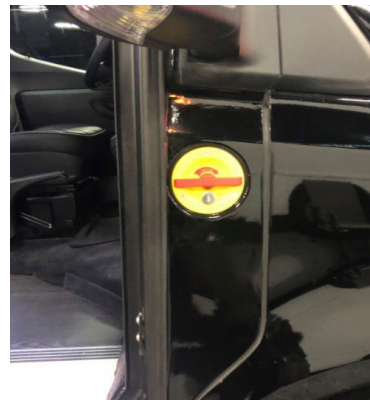
Exterior door release valve at the entrance door of a custom limousine.

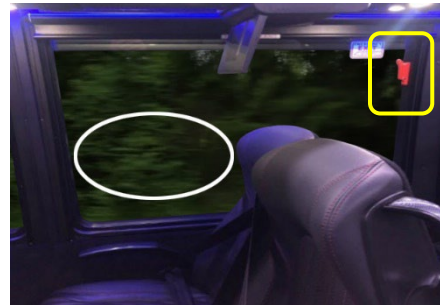
Two rows of seats occupy the exit space. There is only one release mechanism to open the exit located in the space to the right. A marking indicating the location of the release mechanism is missing in the exit space of the seat to the left.

- c. Release Handle Labels.** Buses may be manufactured with more than one row of seats within the area of the emergency exit space. Determine whether an emergency exit release mechanism is located in the occupant space of each seat within the exit area. If a release mechanism is not present, a label must be placed within the occupant space to indicate the location of the nearest release mechanism for that exit. If the marking is missing, a violation is present. (393.62(e)-(571.217 S5.5.1))

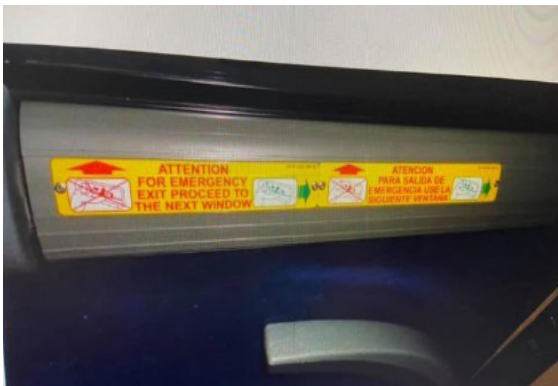
Pictograph and text clearly indicating this non-opening window is not an emergency exit and the location where the exit may be

**e. Markings used in addition to those required.** Many manufacturers or motor carriers apply labels to non-opening and/or non-emergency exit windows to indicate the location of the nearest emergency exit. This is not a marking requirement in the FMCSRs or FMVSS/CMVSS 217.

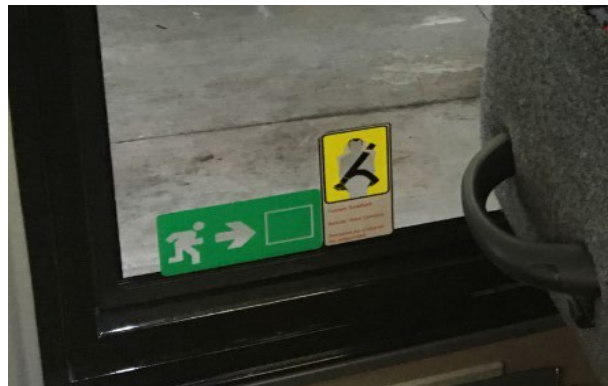
Green pictograph indicating an exit is located to the front of this occupant's space.

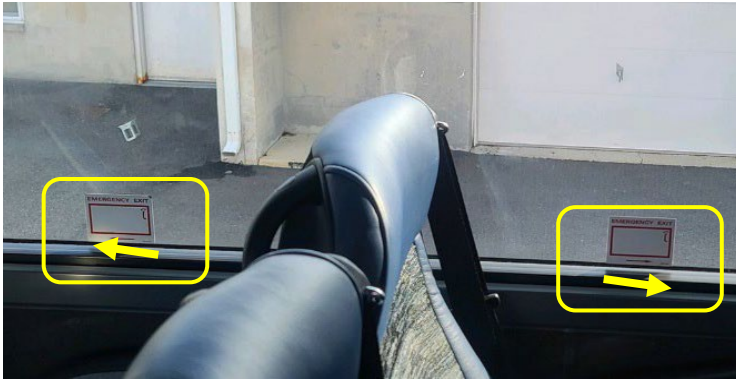
These markings, placed on a non-opening window, do not clearly differentiate between an actual emergency exit and where one can be located.

**f. Improper use of additional markings.** If a manufacturer or motor carrier chooses to provide additional marking (for non-emergency/non-opening windows) to indicate the location of the nearest emergency exit, the marking must differ from those used to identify an emergency exit. The use of markings placed on non-opening/non-emergency windows may not be identical to markings used to satisfy the requirements in the FMCSRs/FMVSS/CMVSS. If a marking used to satisfy the requirements of 393.62 is placed on a non-opening/non-emergency window, an out-of-service condition exists for “marked emergency exit inoperative.” Such markings may be misconstrued as an operative exit and confuse passengers in an emergency situation. (393.62(a)-(571.217 S5.3-S5.4) – Side emergency exit window fails to meet the required standard.)

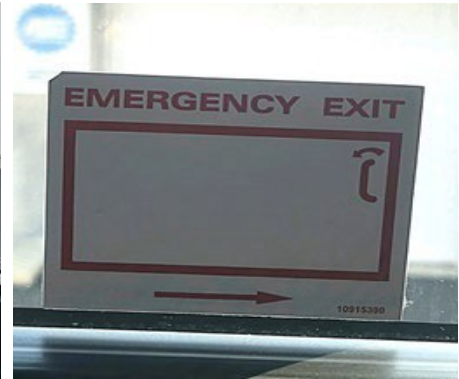
This same marking would be acceptable when found in the occupant space of an emergency window with a single release mechanism to the right.
